INDOOR AIR QUALITY ASSESSMENT

**Acushnet Elementary School
One Concord Road
Acushnet, Massachusetts**

Prepared by:
Massachusetts Department of Public Health
Bureau of Environmental Health Assessment
July, 2002

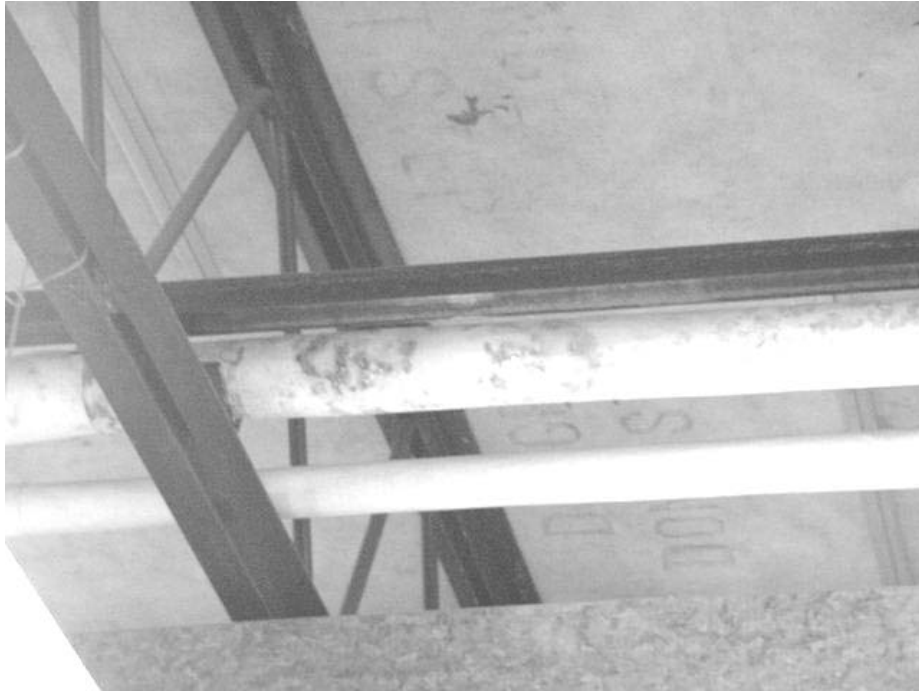
Picture 1

Water-damaged pipe insulation was observed in classroom 16 (see Picture 1). Fiberglass and paper wrapping around pipes are porous materials; if wetted repeatedly they can provide a medium for microbial growth.

Water-Damaged Pipe Insulation in Classroom 16

6. Remove or encapsulate damaged/exposed fiberglass in classrooms.

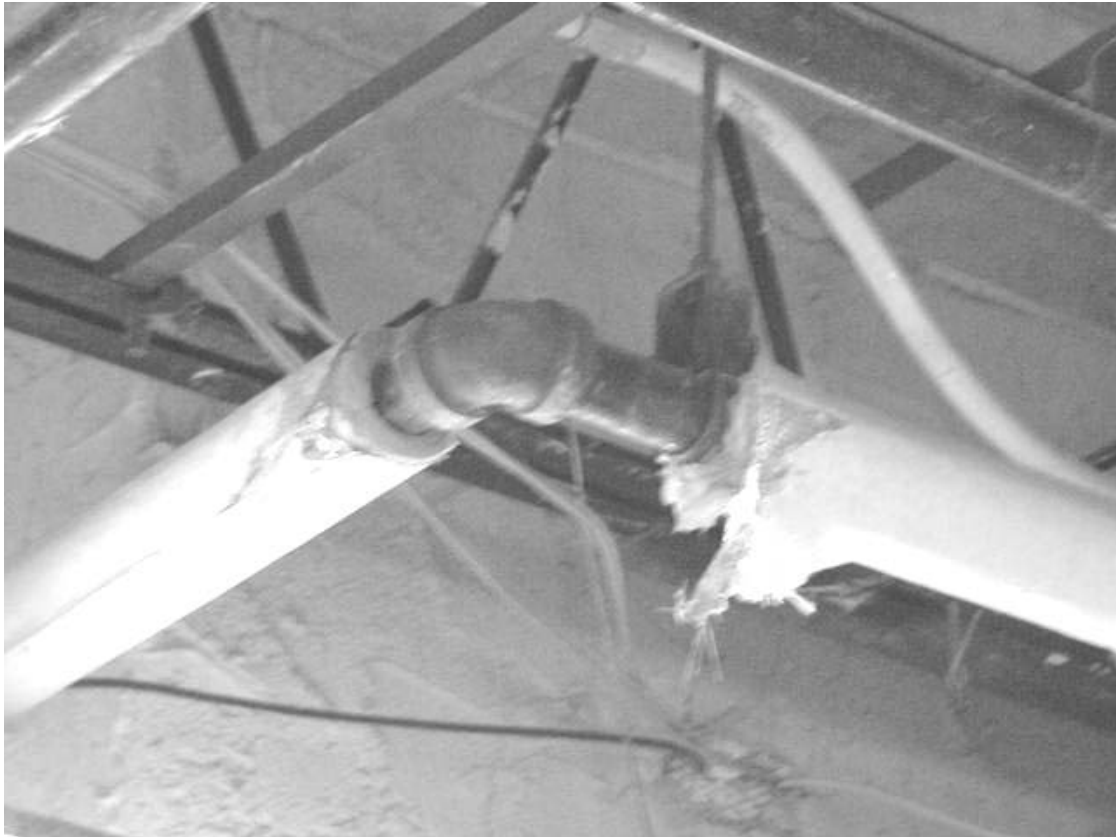
Picture 2

Several conditions that can potentially affect indoor air quality were also identified. Exposed fiberglass insulation was noted around pipes in classrooms 14 and 16 (see Picture 2).

Damaged Pipe Insulation/Exposed Fiberglass

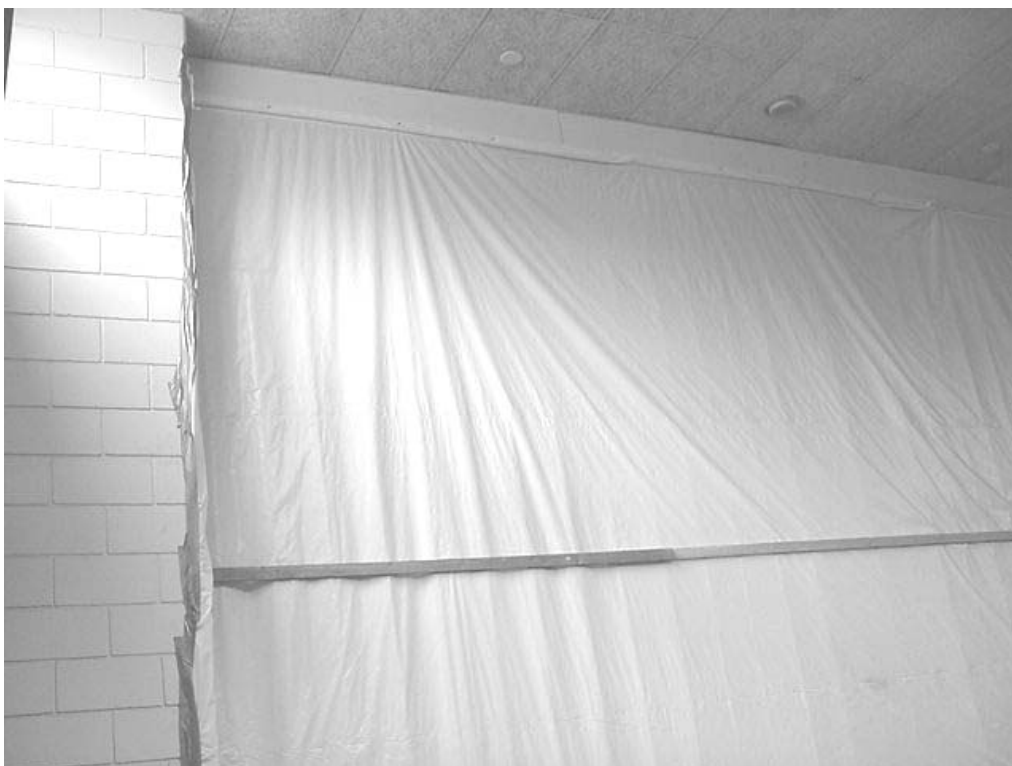
Picture 1

gymnasium from the occupied cafeteria (see Picture 1). Plastic polyethylene sheeting was also erected on the interior of the gymnasium wall inside the construction zone, however prior to the BEHA assessment the plastic sheeting was removed, per order of the Fire Chief, to be replaced by fire-rated plastic polyethylene sheeting. Two local exhaust ventilation units equipped with high efficiency particulate arrestance (HEPA) filters were positioned within the construction area in a manner to draw airborne construction debris away from the cafeteria and outside the building (see Picture 2). Two large industrial sized exhaust fans were also placed in a construction door (see Picture 3) to help create depressurization and to minimize the potential of airborne contaminants to penetrate into occupied areas of the school. Gymnasium doors leading to the adjacent corridor were sealed with plastic polyethylene sheeting on the construction side and with duct tape on the occupied side (see Picture 4). Mr. Holmes recommended sealing these doors with plastic polyethylene sheeting and duct tape on the occupied side to create a secondary barrier.

Plastic Poly Containment Wall in Cafeteria

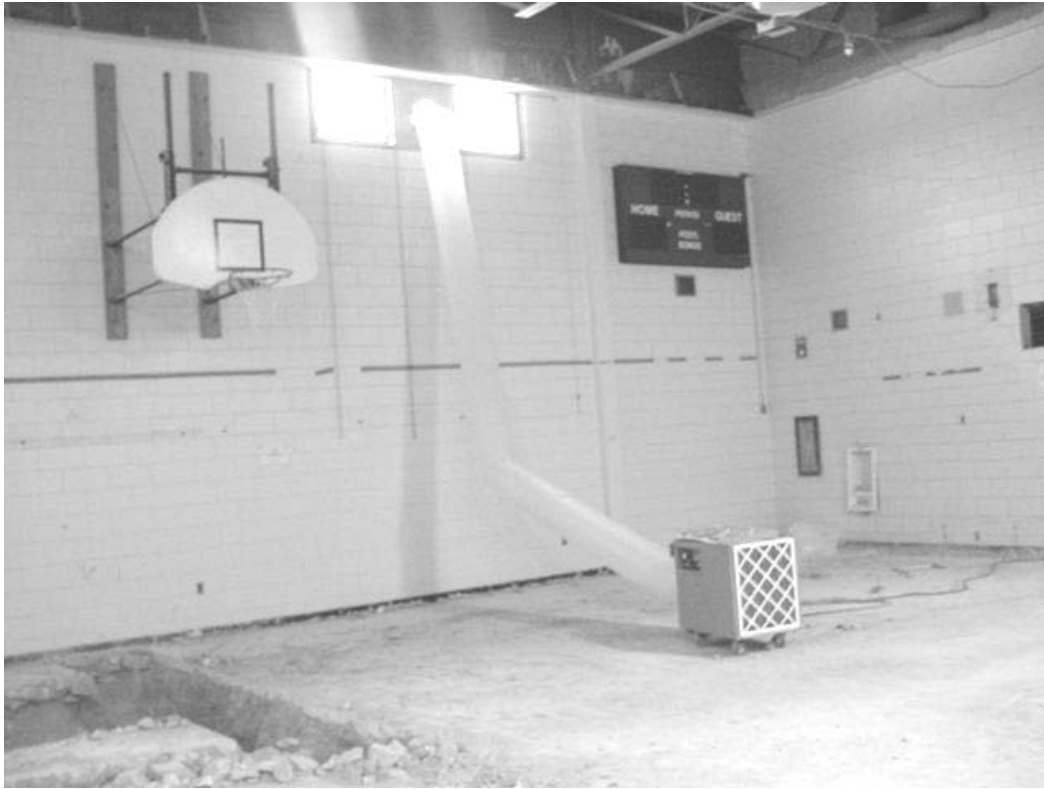
Picture 2

One of Two Negative Ventilation Units Equipped with HEPA Filters in Gymnasium

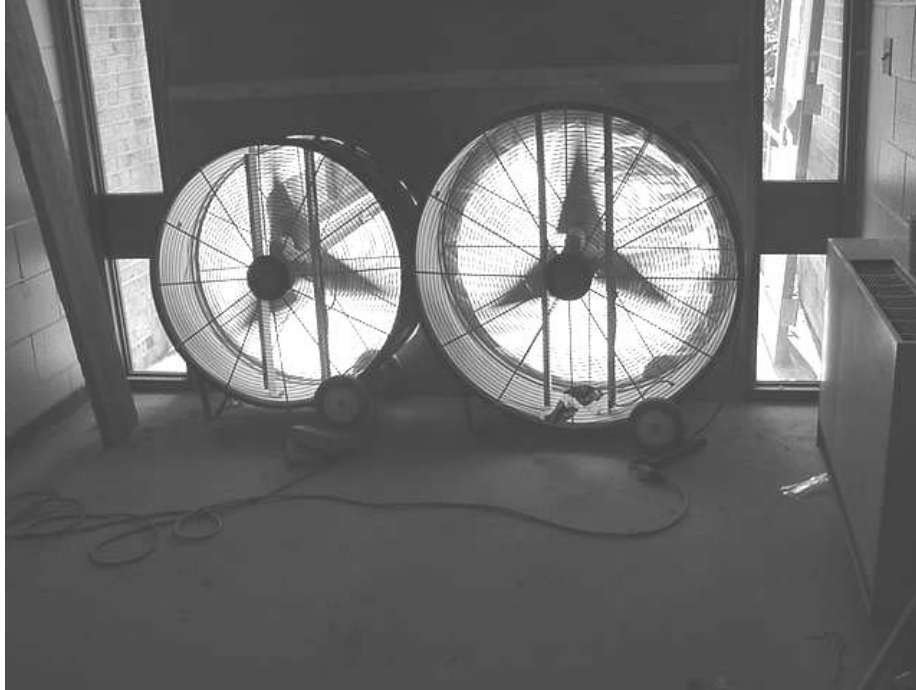
Picture 3

Exhaust Ventilation Fans in Construction Zone

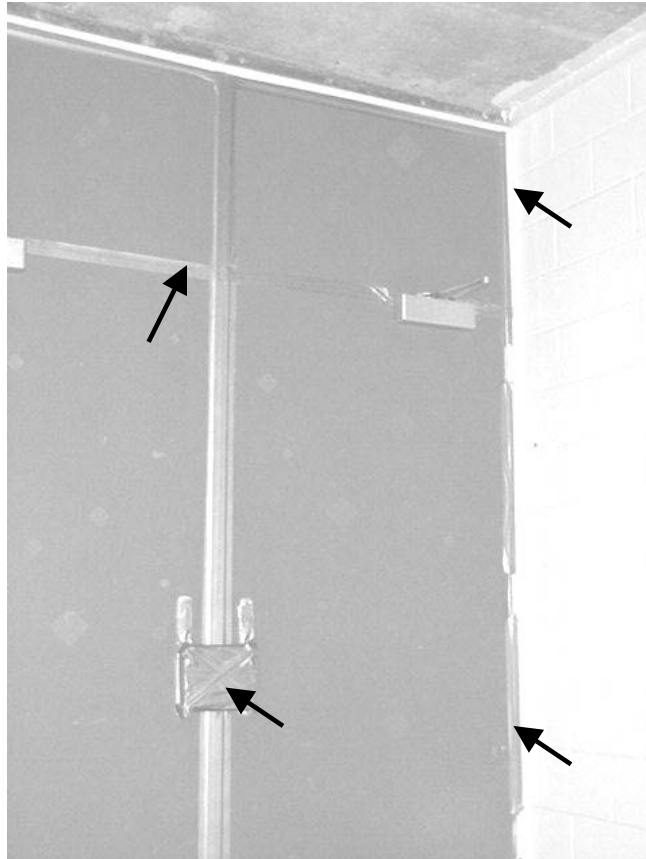
Picture 4

Gymnasium Door Seams Sealed With Duct Tape

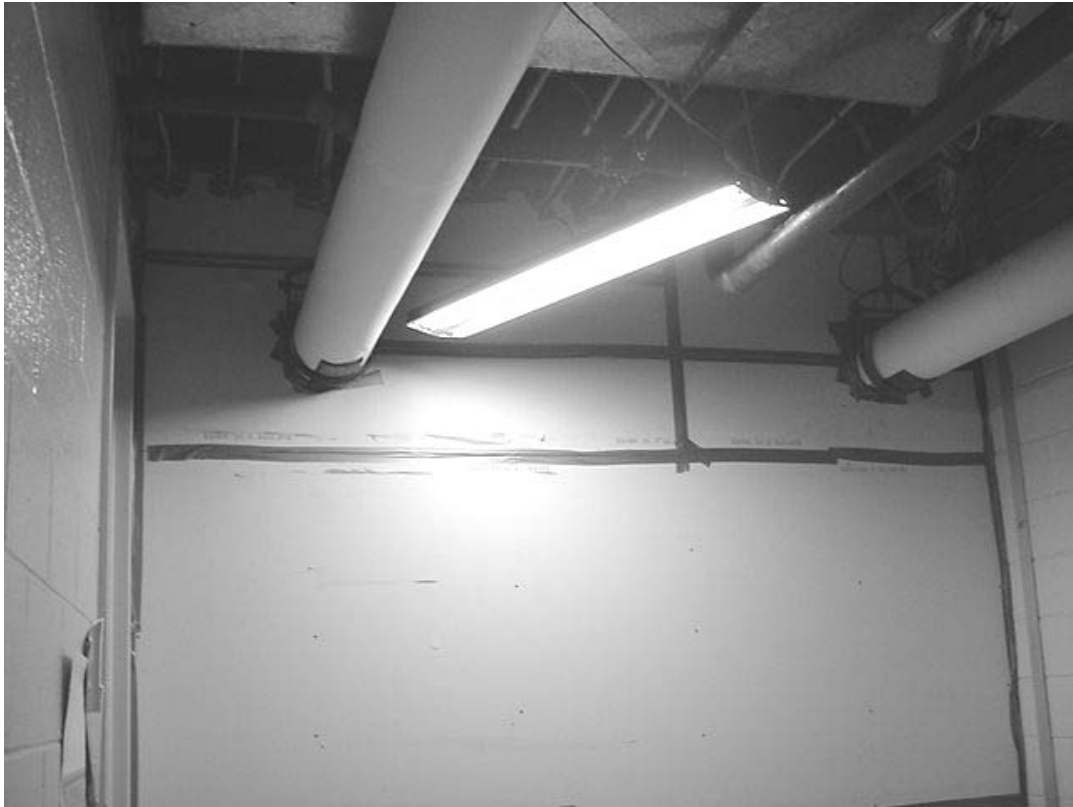
Picture 5

**Temporary Gypsum Wallboard Containment Barrier in Corridor,
Note Utility holes Sealed with Duct Tape**

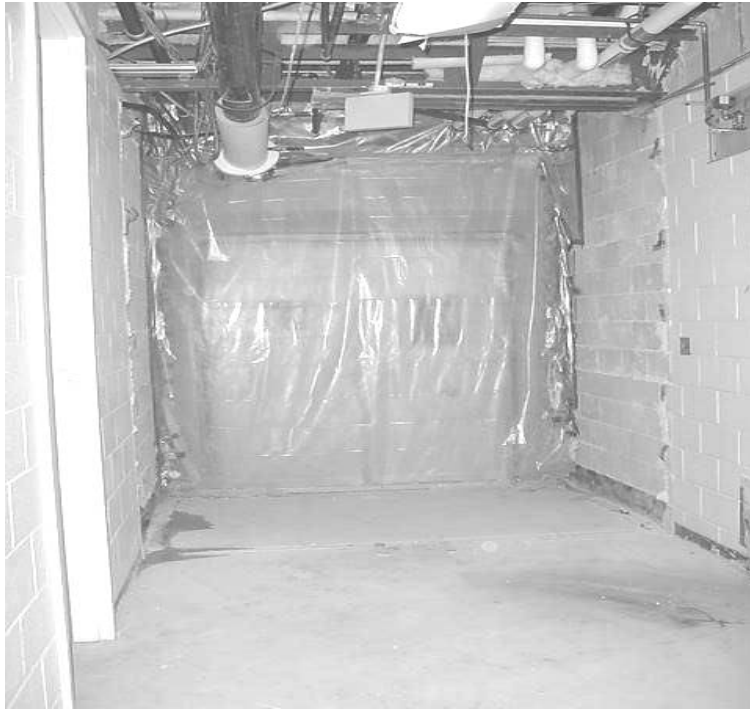
Picture 6

Picture Taken of Containment Barrier Shown in Previous from the Construction Side

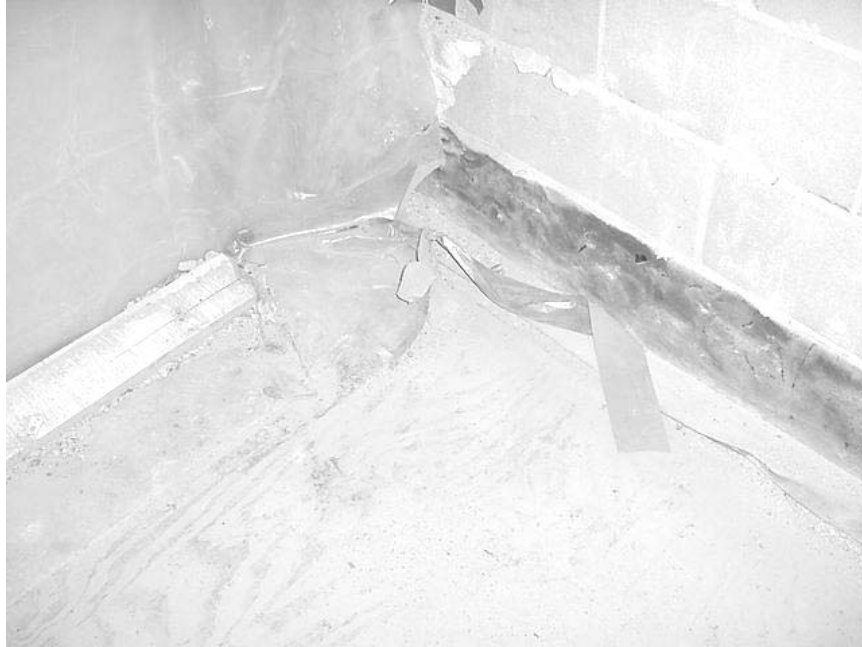
Picture 7

Close-up of Containment Barrier in Previous Picture, Note Loose Duct Tape and Plastic Poly Due to Dusty Conditions

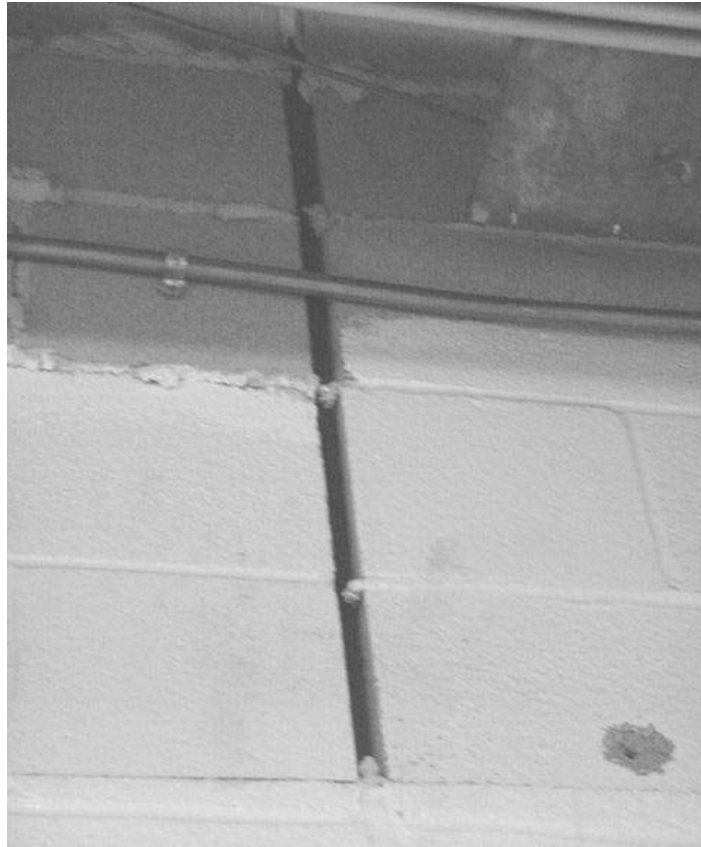
Picture 8

Wall Crack in Corridor Adjacent to Construction

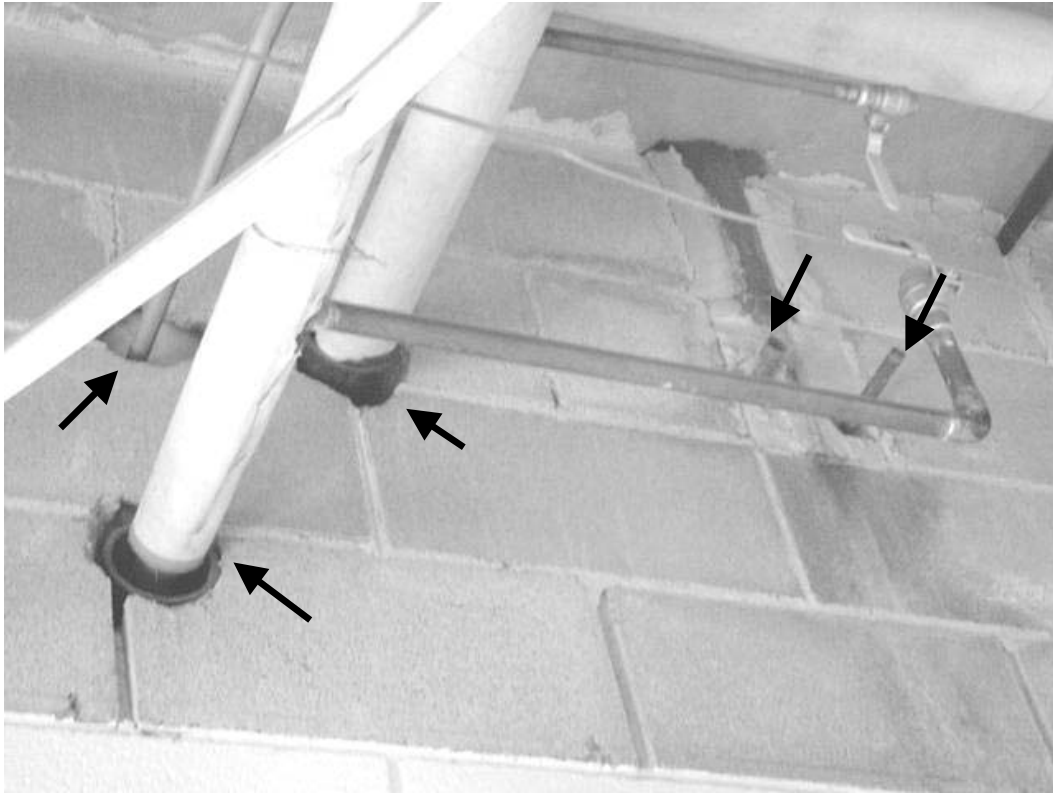
Picture 9

Open Pipes and Utility Holes in Classroom 26 Adjacent to Construction Zone

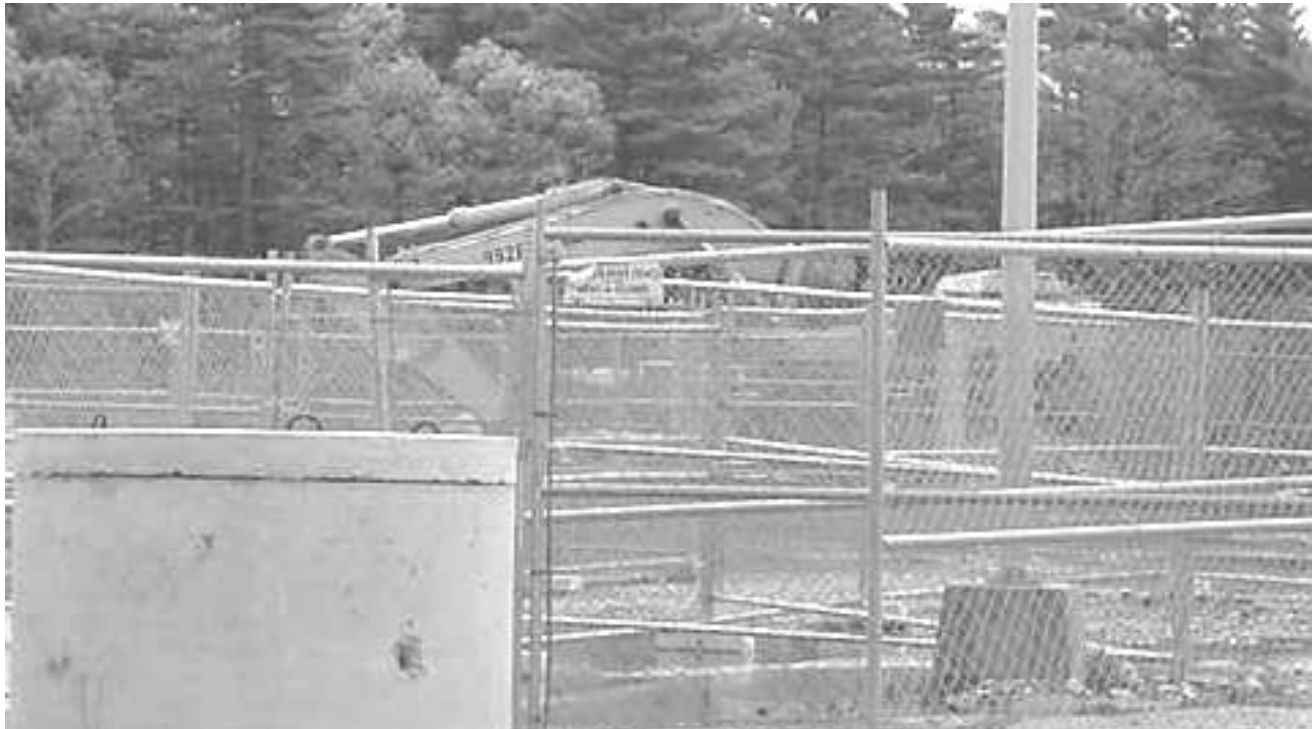
Picture 10

Construction Vehicle in Close Proximity to the Building

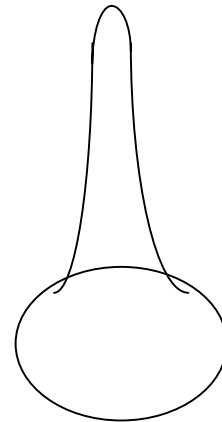
Figure 1

3. Classroom occupants reported similar stains on vertical surfaces (e.g. sides of bookcases and chalkboards) several feet above the ground (see Picture 12). Stains examined on vertical surfaces were roundish as opposed to elongated (teardrop shaped) and pointing towards the floor (see Figure 1). If the source of liquid that created the stains originated *above* the vertical surface, a typical teardrop pattern of staining should be produced. These stains are not teardrop shaped, but are of a stain pattern would indicate that the direction that the liquid was traveling was either on the same horizontal plane or below the vertical surface.

Individual Stain Pattern in Room 13

**Typical Drip Pattern Seen from Source originating
above a vertical surface**

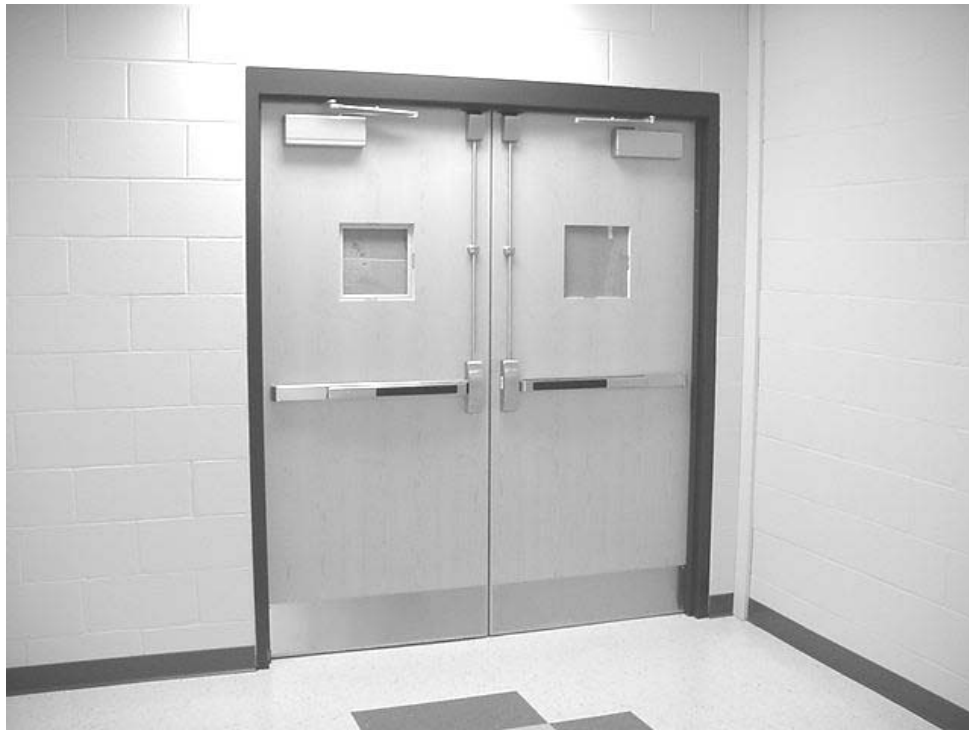
Picture 1

Doorway Adjacent to Gymnasium in New Addition

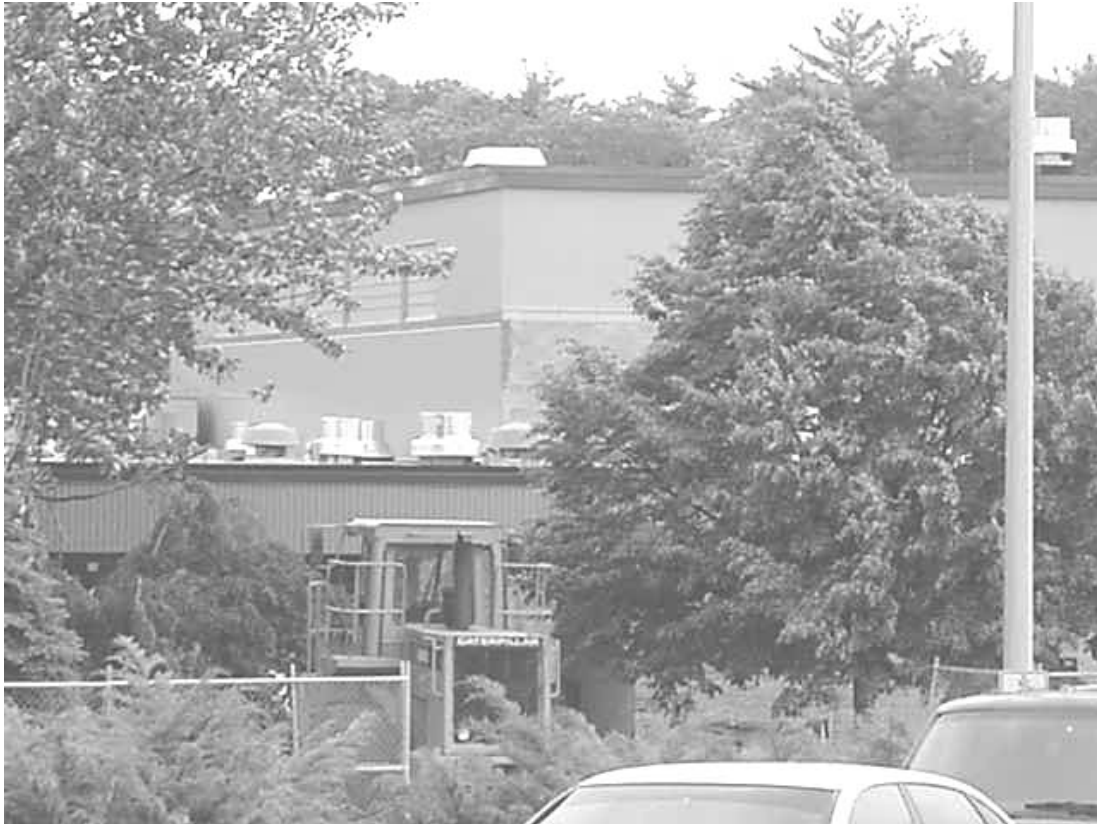
Picture 2

Construction Vehicle in Close Proximity to Building

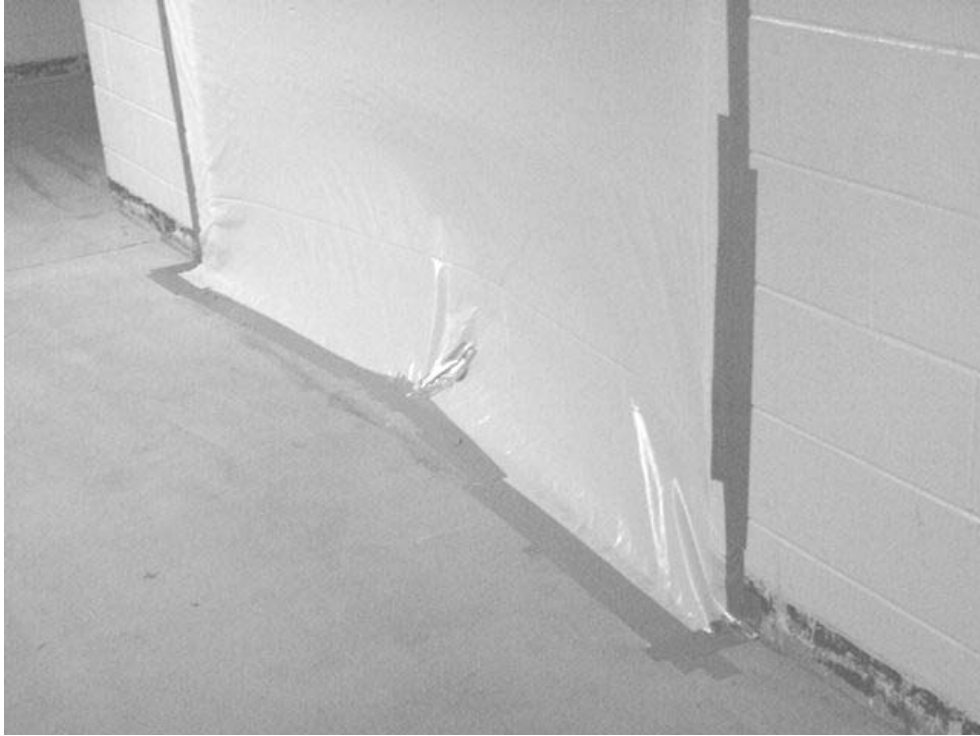
Picture 3

Depressurized Gymnasium Construction Barrier, Note Plastic being Drawn Away From Occupied Hallway

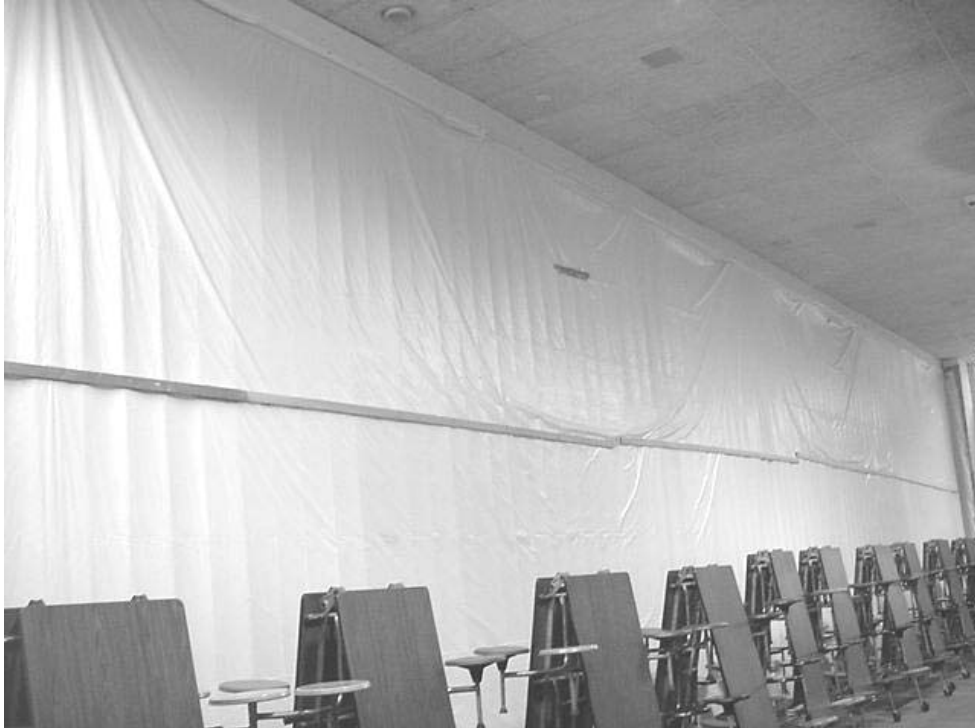
Picture 4

**Depressurized Gymnasium Construction Barrier, Note Plastic being
Drawn Away From Occupied Hallway**

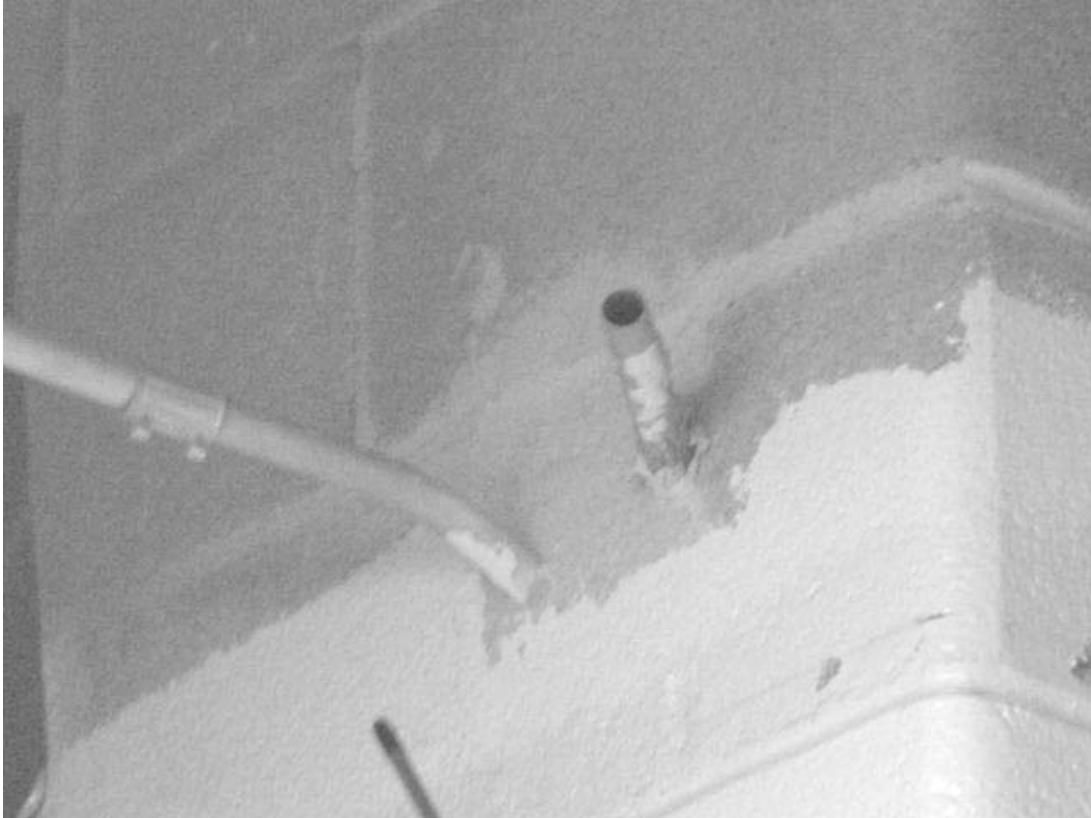
Picture 5

Open Pipe in Hallway Adjacent to Construction

BEHA staff also recommended that further examination and sealing of utility holes, pipes and wall cracks (see Pictures 5 - 7) be conducted in all containment barriers and existing classroom/hallway walls to eliminate any potential pathways of pollutant migration.

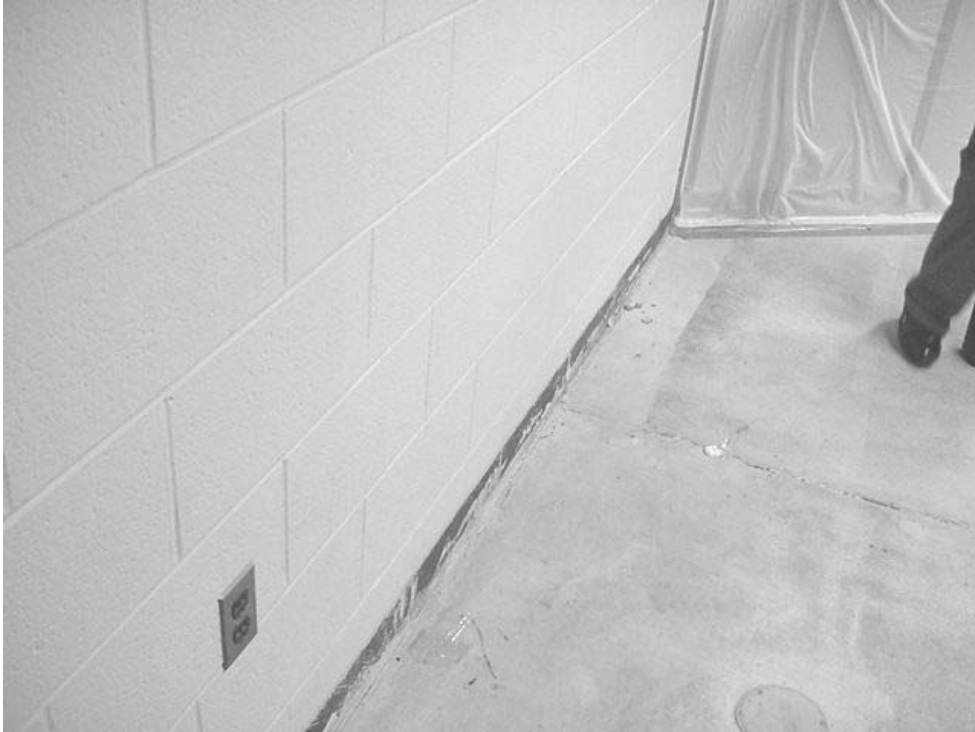
Picture 6

Electrical Outlet in Close Proximity to Construction Barrier in Foreground

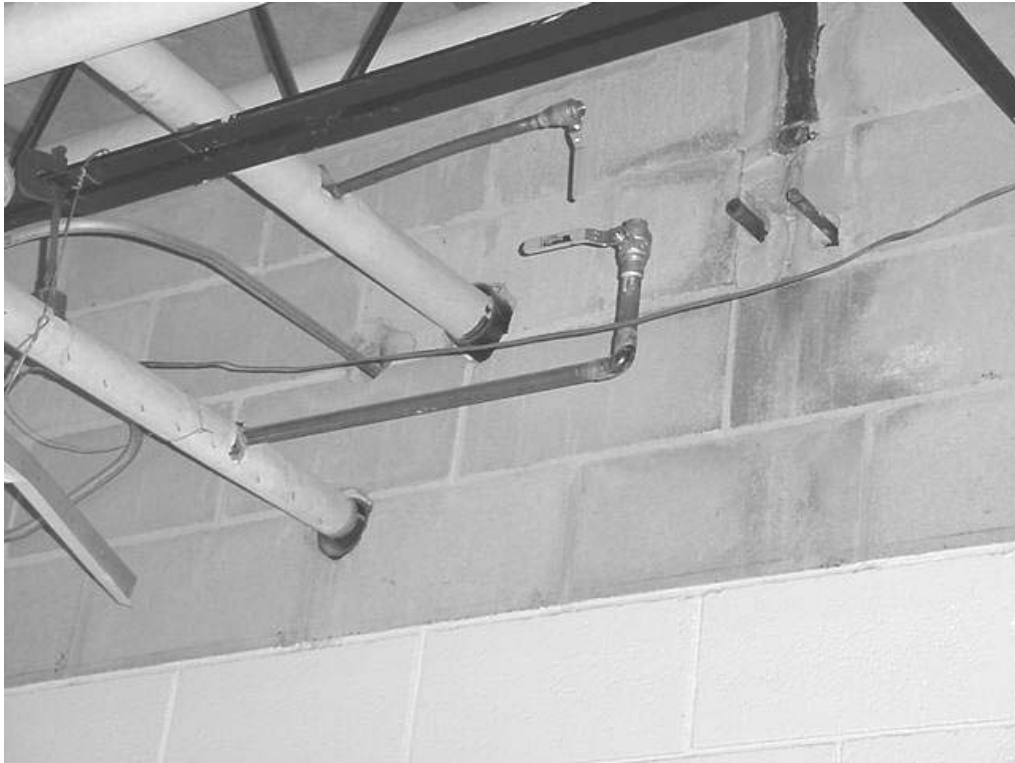
Picture 7

**Open Utility Holes in Classroom 26, Some Utility Holes were Sealed
Others Were Not**

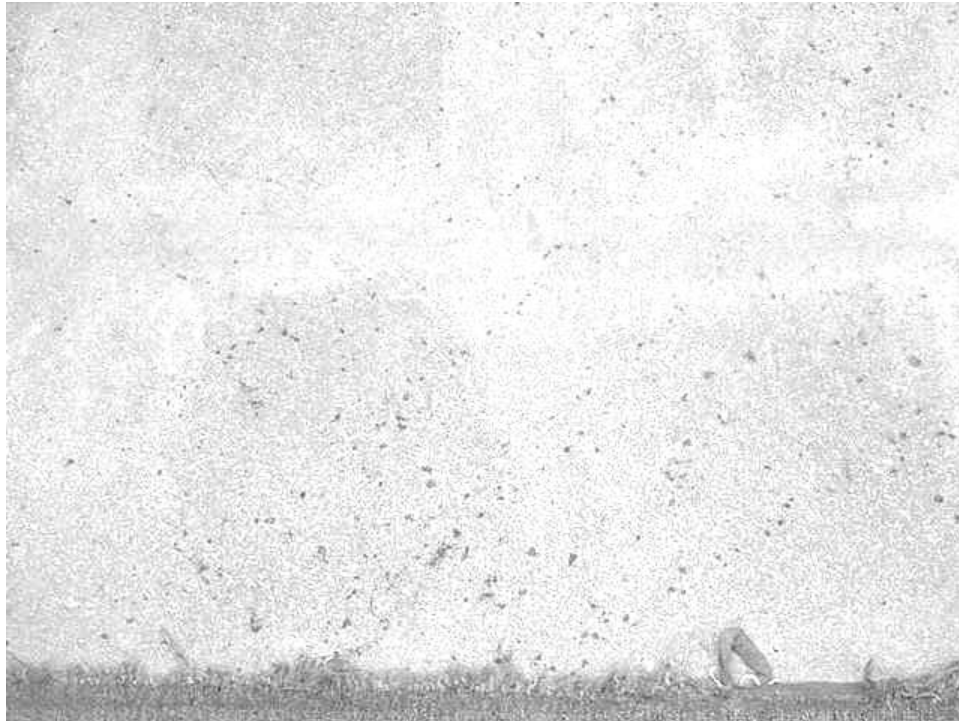
Picture 8

Dark spots of a material exist on the floor, easel, shelf and carpeting in an approximate 20 foot long by 6 foot wide section of the classroom roughly 15 feet from the hallway door. The source of these stains appears to exist within the classroom and not the roof for the following reasons.

Based on visual observations by BEHA staff, reports from local health and school officials responding to the incident and an interview with the room 13 teacher, the most likely source of the splattered stains were from within the classroom, possibly by shaking of the ruptured pen found in the trash barrel by a student.

Splattered Stains on Floor of Classroom 13; Reported to be Roofing Material

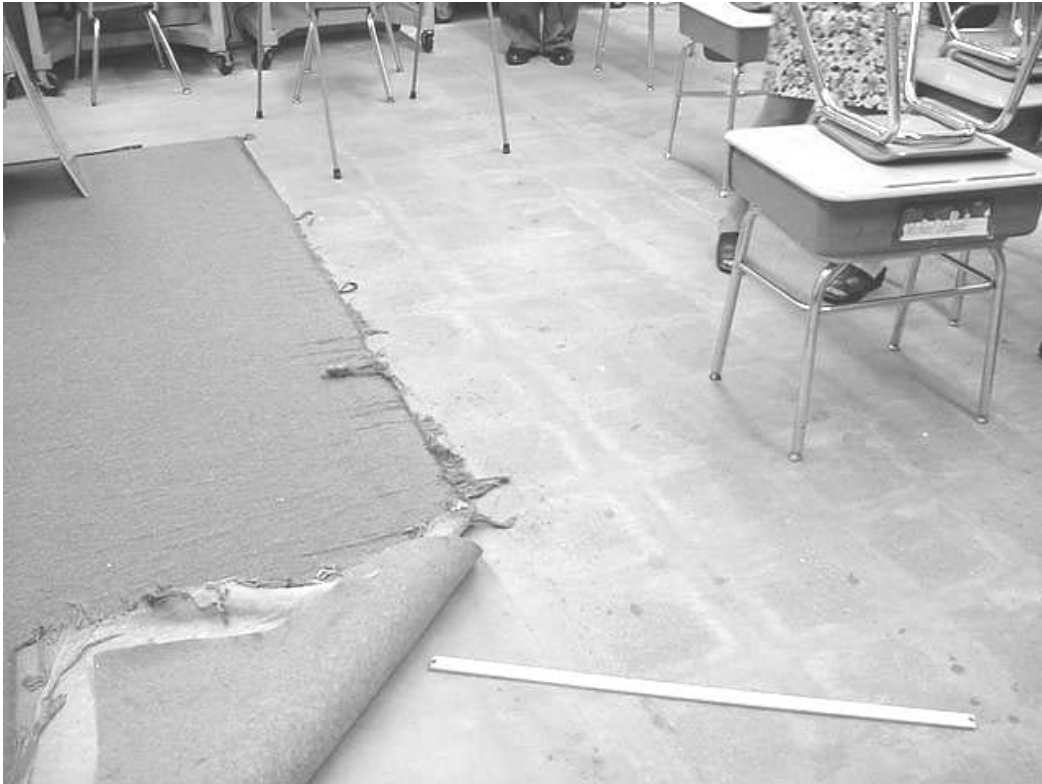
Picture 9

Area of Classroom Believed to be Where the Incident Occurred

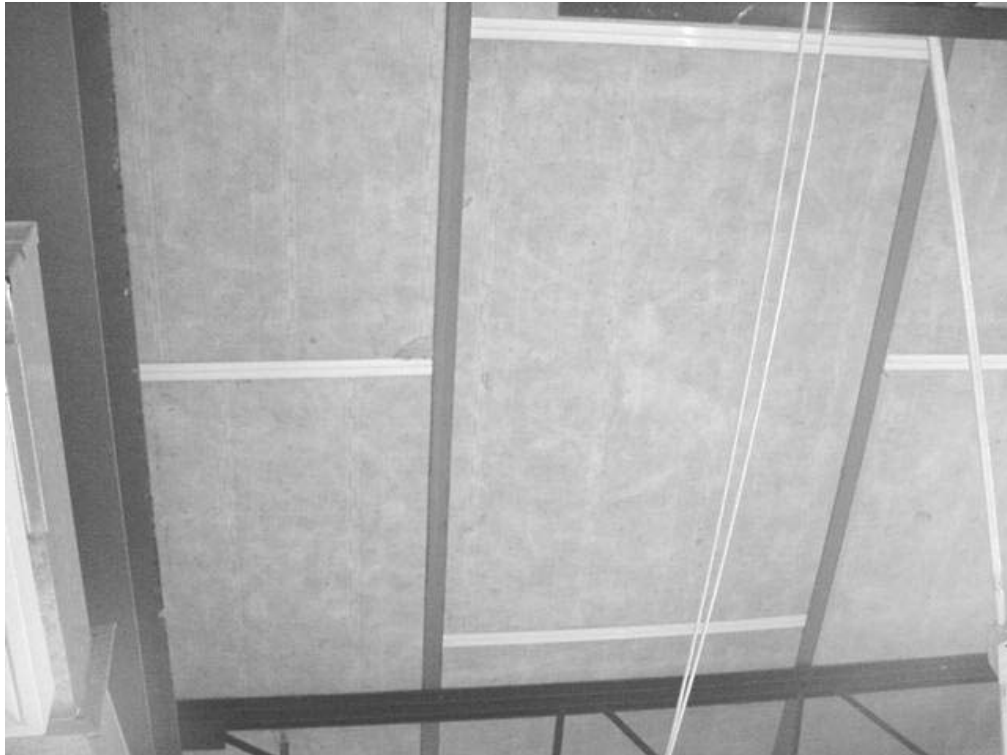
Picture 10

1. BEHA staff conducted a visual inspection of the ceiling, and found no evidence whatsoever of leaking roofing material. The ceiling of classroom 13 was found to be wholly intact (no breaches) and free of stains (see Pictures 10 & 11). If a molten/liquid roofing material were to have entered the space via holes in the ceiling it would have left stains in insulation, support beams or other building ceiling structures directly above the stains found on the floor and desks. Removal of these stains would be extremely difficult, since ceiling insulation is porous and would be expected to absorb liquids to produce stains.

Classroom 13 Ceiling above Splatters; Note Ceiling is Intact and Free of Staining

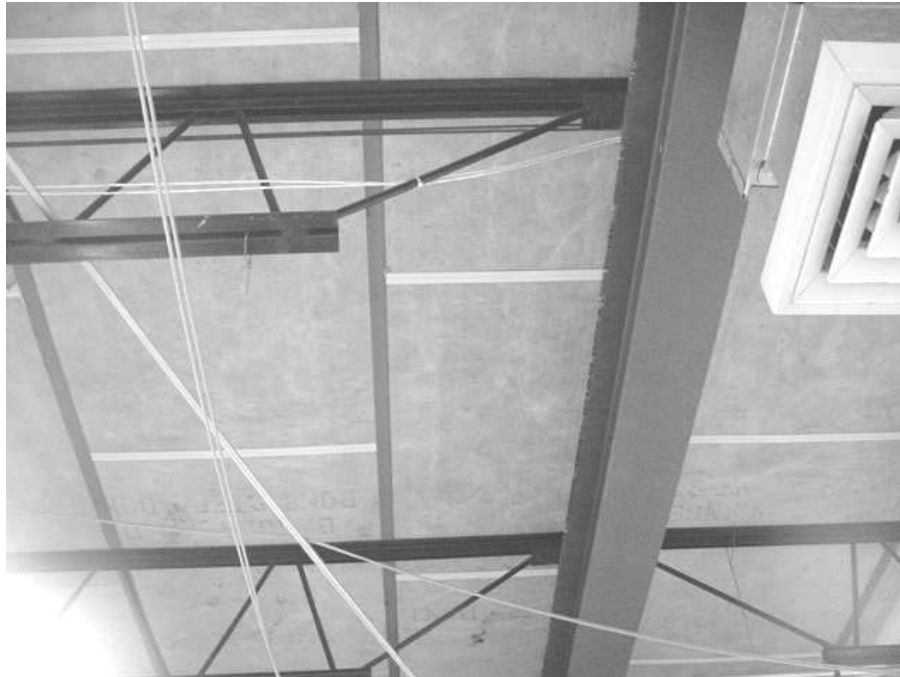
Picture 11

Classroom 13 Ceiling above Splatters; Note Ceiling is Intact and Free of Staining

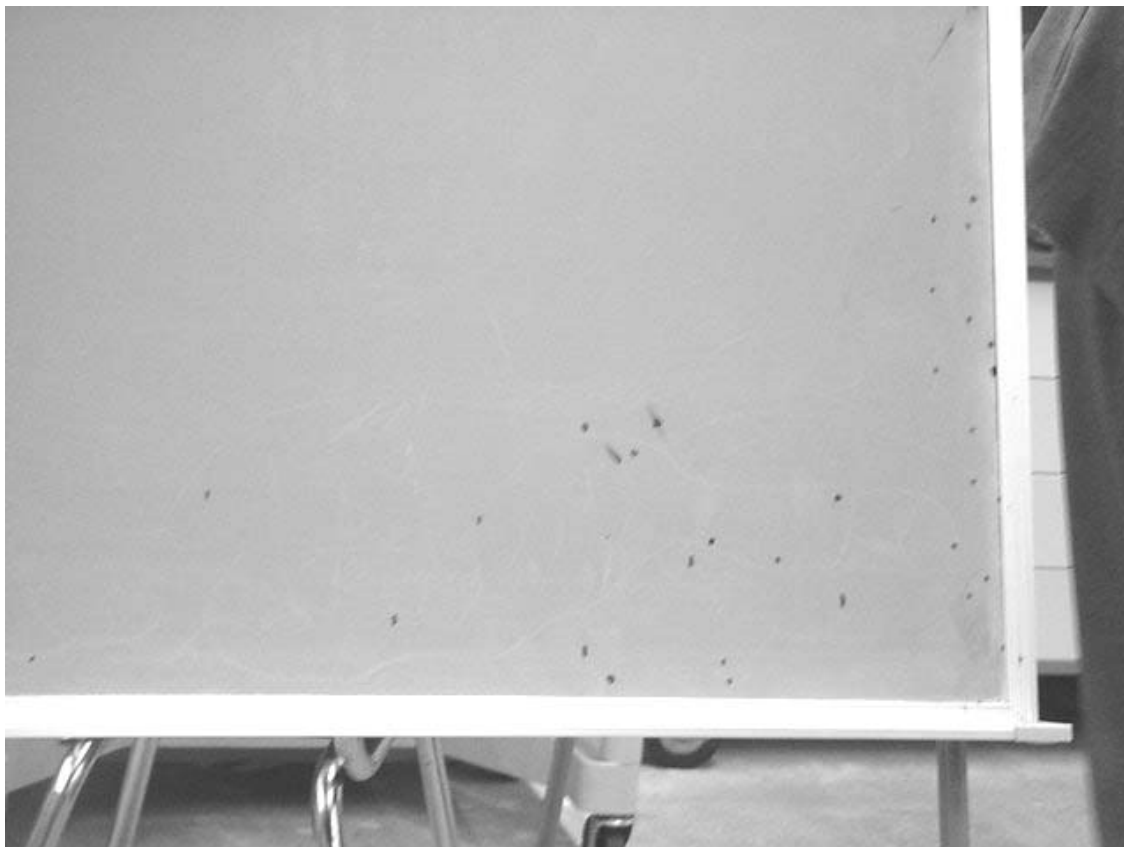
Picture 12

Vertical Staining Pattern on Chalkboard in Classroom 13
